Commercial Inspection

6300 North Davis Hwy
Pensacola, Fl 32504

Perdido Inspection Services

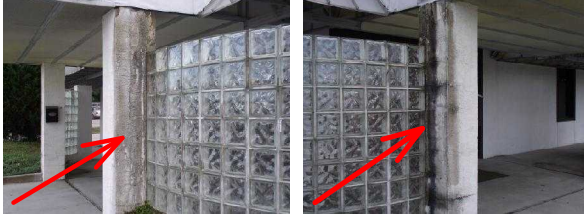
1. Type: Stucco Stucco column cosmetic features at front of building

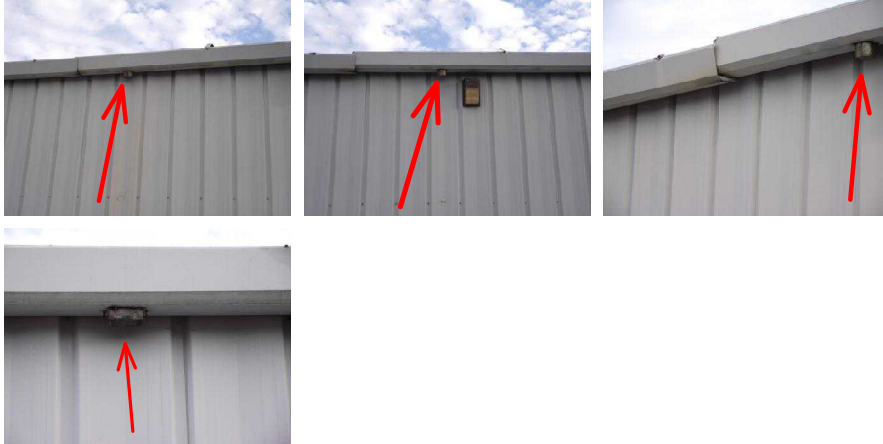
8. Downspouts: Steel Missing or broken sections

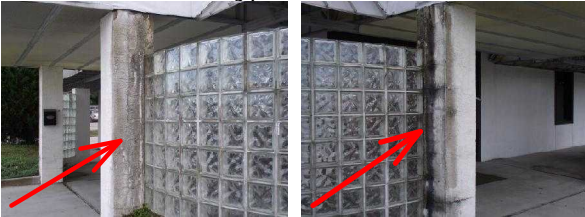
1. Exterior Surface Type: Stucco Stucco column cosmetic features at front of building

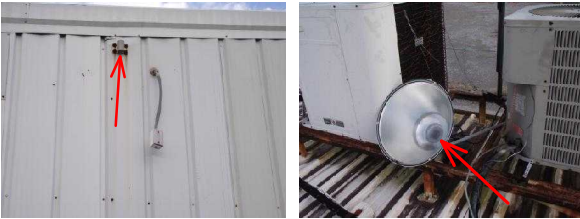
3. Exterior Lighting: Surface mounted lamps front and rear Parking lot light at rear not attached and sitting on roof.

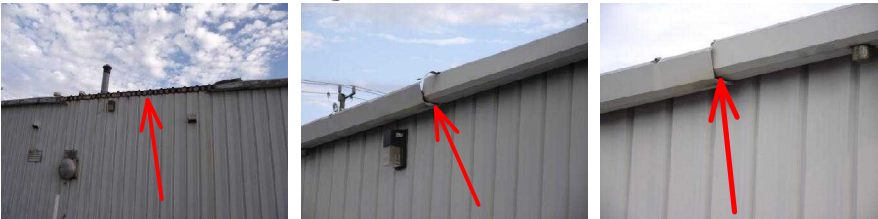
5. Gutters: Steel Missing Sections and broken sections.

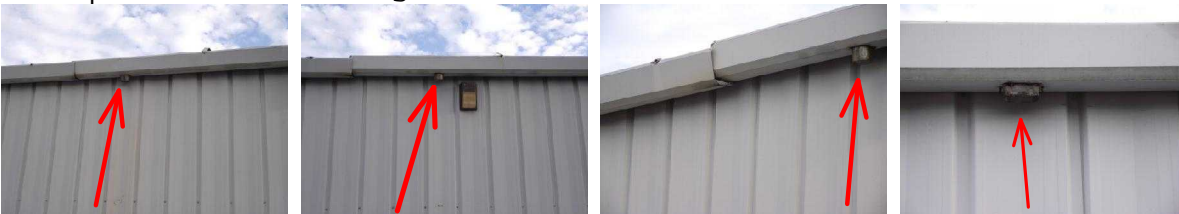
6. Downspouts: Steel Missing or broken sections
