# Perdido Inspection Services LLC

807 North 1st St.  
Jacksonville Beach, Florida 32507

17:54 January 06, 2011

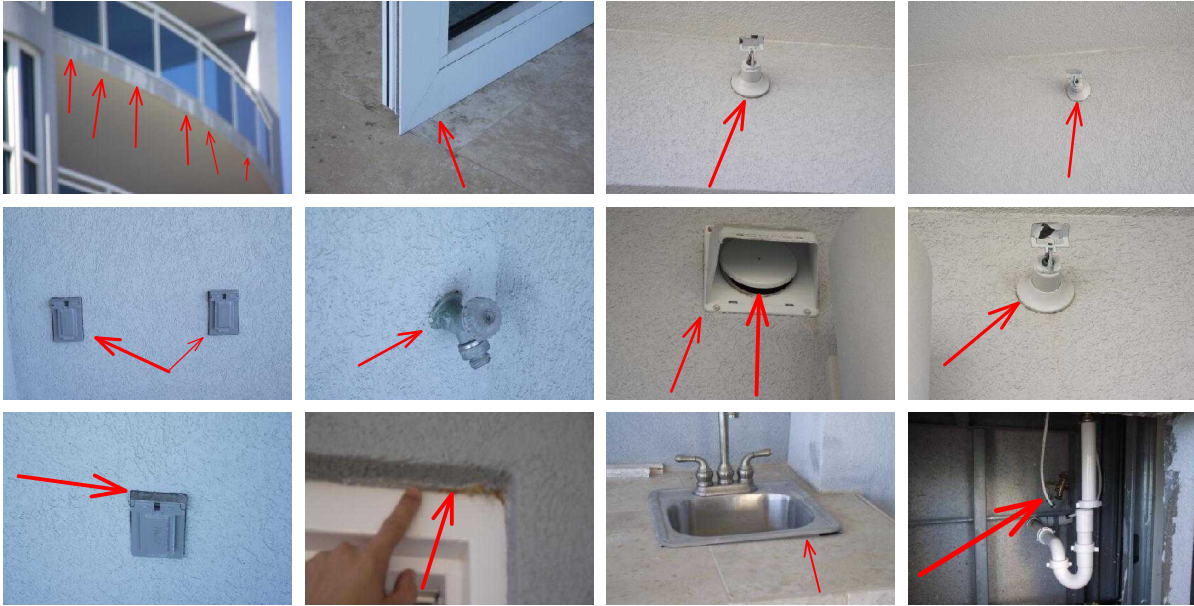
- Stucco
  Exterior doors
  Exterior Penetrations
 Please note exterior issues with stucco, caulking at penetrations, exterior doors, Exterior patios at same height or higher than interior floors, plumbing not hooked up and sink not installed, staining on face of balcony on stucco and exterior doors dragging on tile surface. These issues can be corrected by qualified contractor.
